Historic England

Energy Efficiency and Historic Buildings

Open Fires, Chimneys and Flues

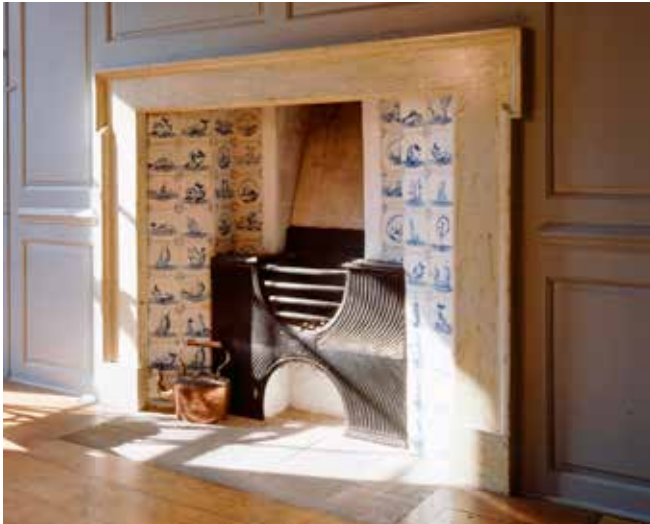
Figure 3 (above)
An 18th century cast iron grate in a fireplace at the Great Yarmouth Row Houses.

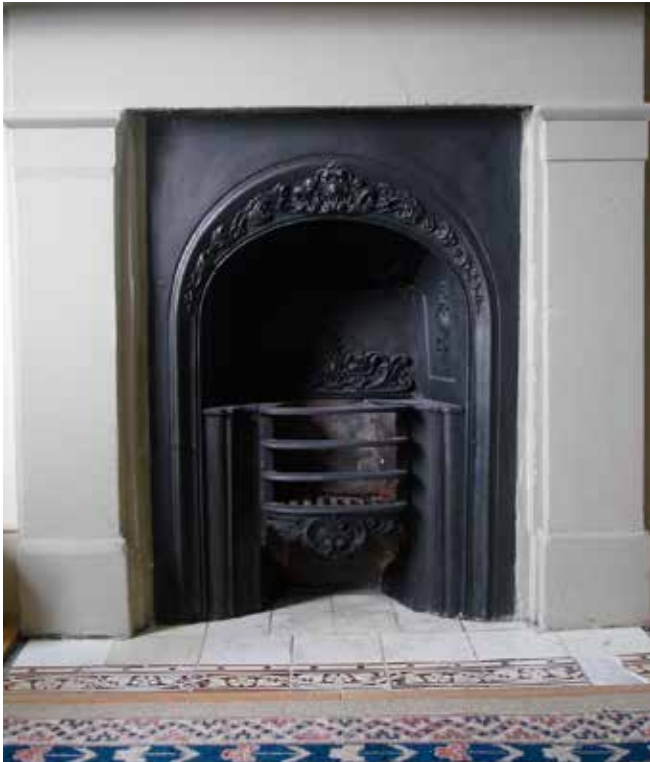
Figure 7
Cast iron fireplaces such as this one often incorporated built in dampers to restrict draughts when the fireplace was not in use.

A chimney for an open fire will be a cause significant draughts when it is not in use. A good remedy for this is to fit a damper, which can be installed either in the throat of the chimney, the flue or at the top of the chimney. The best types are easily opened and closed using a handle that also indicates the position of the damper flap. Dampers should not block all the air entering the chimney as a small permanent flow is necessary to ventilate the flue when it is not in use. If a gas appliance is to be used any damper must be fixed in the permanently open position.

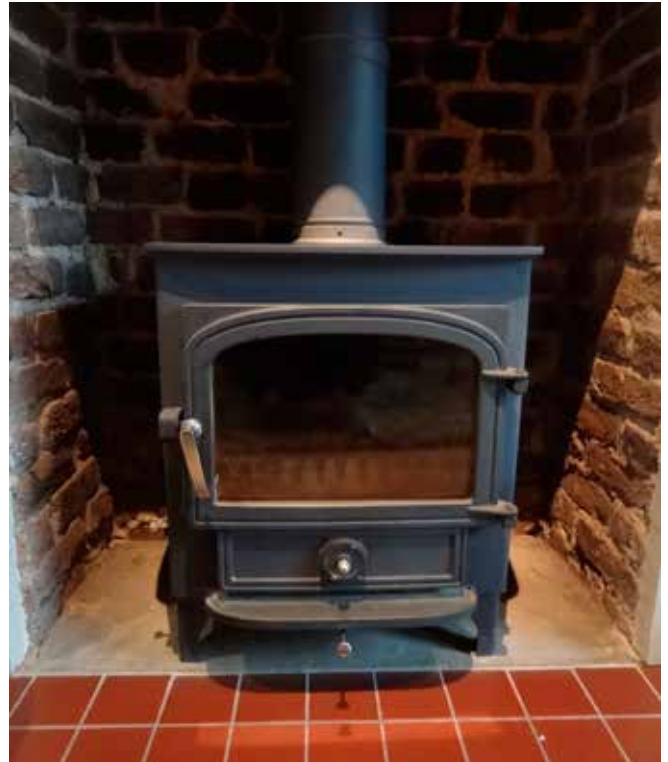
Figure 8
Stoves burn fuel much more efficiently than open fires and cause fewer draughts.

A 'room heater', an enclosed appliance in which fuels are burnt, can be a suitable alternative to an open fire in traditional buildings. A wide range of designs are available. They burn fuel much more efficiently than open fires and cause fewer draughts. Often they can burn wood logs, scraps, chips and pellets, which can help to reduce carbon dioxide emissions. Gas fired versions are also available.

Heat radiates from the casing and through a glass front and by convection from air passing around or through the appliance. Some room heaters are recessed or semi-recessed into a wall, often in an existing fireplace; others are freestanding away from the wall. Some recessed models have back boilers which can supply hot water or central heating. Freestanding stoves are types of room heater. Certain room heaters are certified as being able to burn wood and coal without creating smoke, allowing wood to be burned in smoke control areas.
